Eastern and Central Africa Expertise Centre

## UCHAKATAJI WA KAHAWA

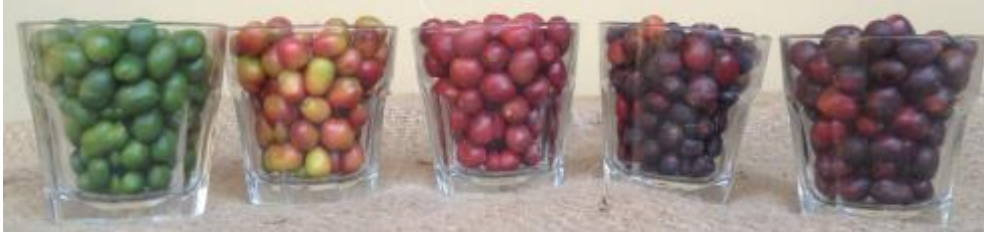
Picha 1: Chuma kahawa yenye alama ya katikati. Kahawa 2 za mwanzo ni mbichi hazijaivaa vizuri na 2 za mwisho zimeivaa zaidi/sana.

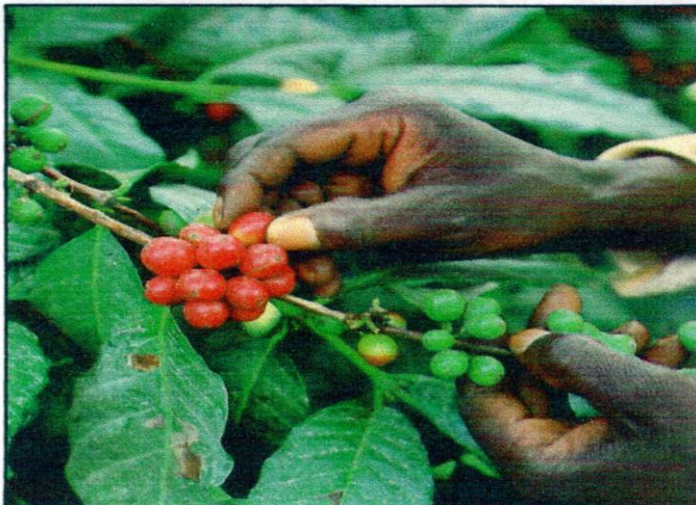
Picha 2: Uchumaji wa kahawa iliyoiva shambani

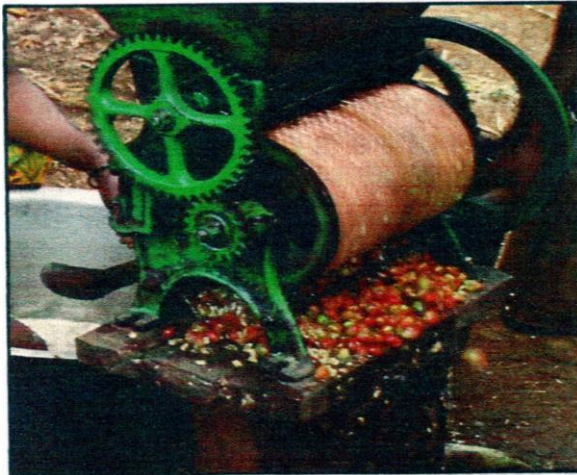
**Picha 4: Mashine ya mkono ya kuchakata kahawa.**

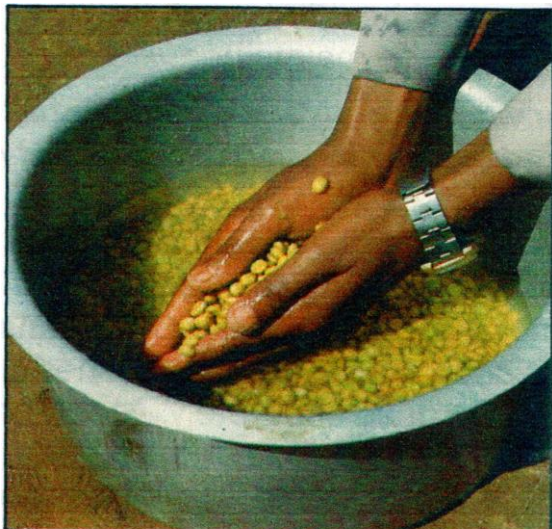
**Picha 5: Kuosha kahawa.**

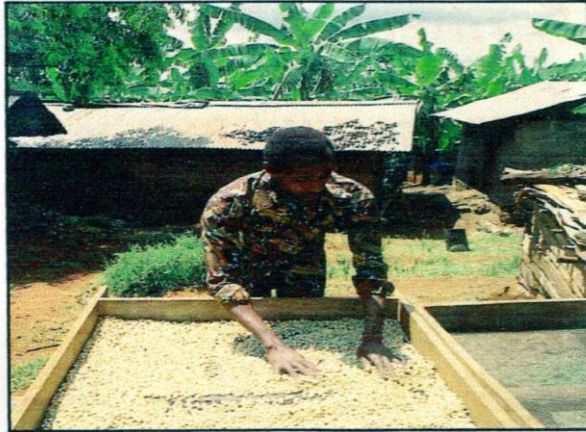
**Picha 6: Ukaishaji wa kahawa iliyooshwa kwenye kichanja/ meza ya wavu**

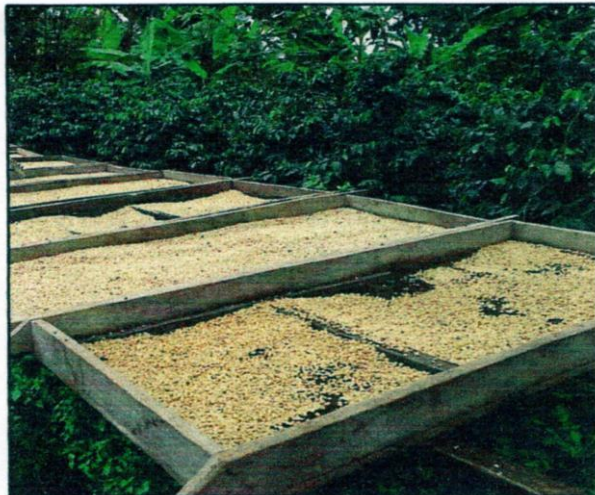
**Picha 7: Vichanja vikiwa na kawahawa.**

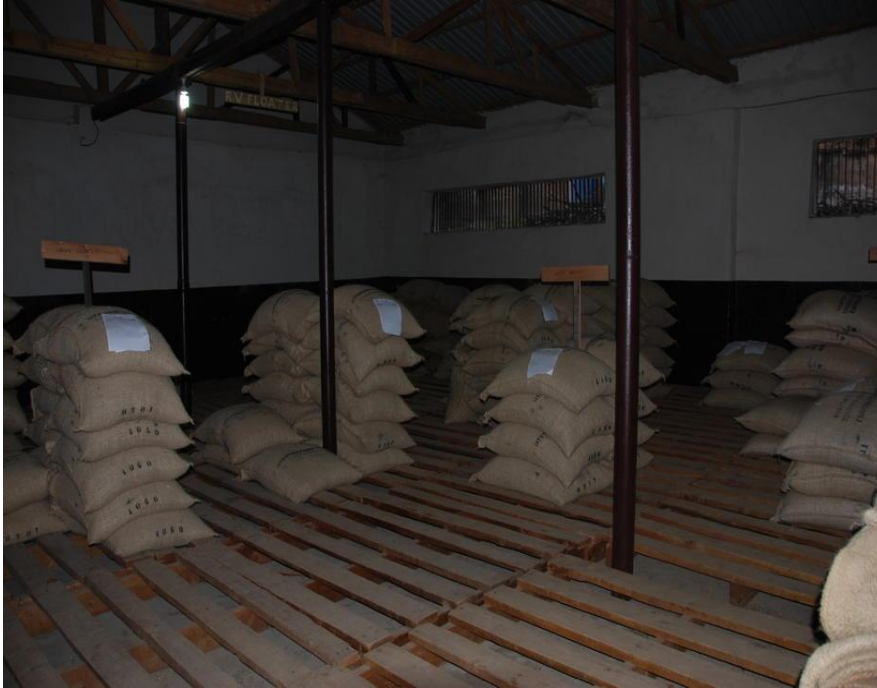
Picha 8: Kahawa ikiwa imehifadhiwa kwenye chaga.
